Ref.: ADITIZOL BASIC paint reference

In 2018, the thermal insulation paint ADITIZOL BASIC was applied in our production plant on two tanks, namely on the tank UT 800 100 – ON THE COOLING WATER SYSTEM and UT 900 010 – GLYCERIN SYSTEM.

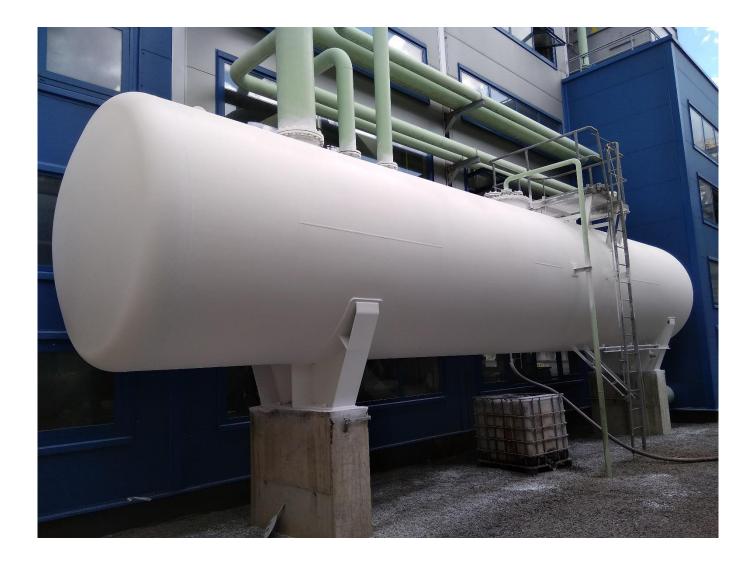
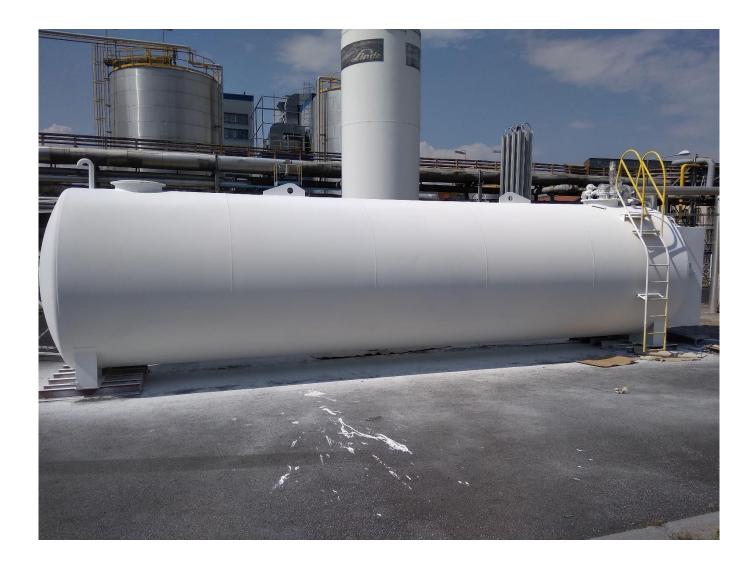
Photo documentation after application of the protective thermal insulation paint is enclosed.

The UT 800 100 water tank warned up in the summer months. A round of tenders was carried out to ensure the insulation of the tanks. We were offered a previously unknown way of insulation the tanks. After the application of the thermal insulation paint, the temperature in cooling circuit stabilized during the summer months. The average temperature has stabilized at 22-23 °C!

The problem with the UT 900 010 tank was the opposite. In this case, in the winter months, glycerine began to solidify in our tank. The tank is designed with mixing of the medium through a small heat exchanger. Previously, despite the mixing of the medium, it solidified and there were problems with exhaustion. After the application of the thermal insulation paint, the temperature value has stabilized and the heating circuit through the exchanger and the pumping of the medium itself is already in order. We keep the temperature in the tank even in the winter months at a temperature of 34-36 °C!
